**EPA**United States Environmental Protection Agency
Washington, D.C. 20460**Water Compliance Inspection Report****Section A: National Data System Coding (I.e. PCS)**

Hagerman National Fish Hatchery (USFWS)

Subject: Hagerman National Fish Hatchery (USFWS), 2011 NPDES Inspection, NPDES Permit IDG-130004

AQUACULTURE FACILITY INSPECTION SURVEY

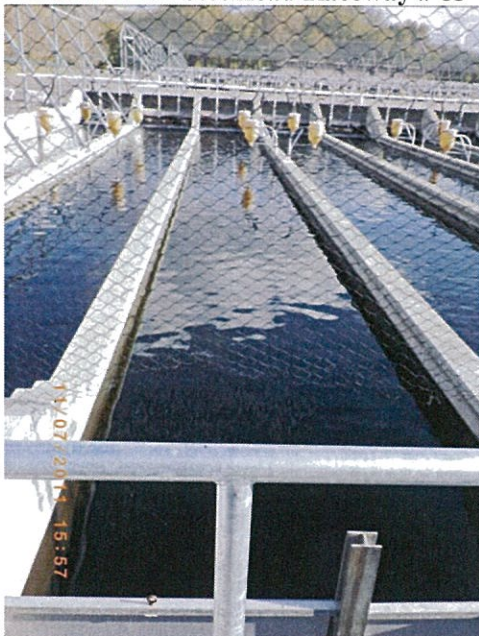
Bottom Deck Steelhead Raceway # 83

Note placement of demand feeders at top of raceway away from quiescent zone.

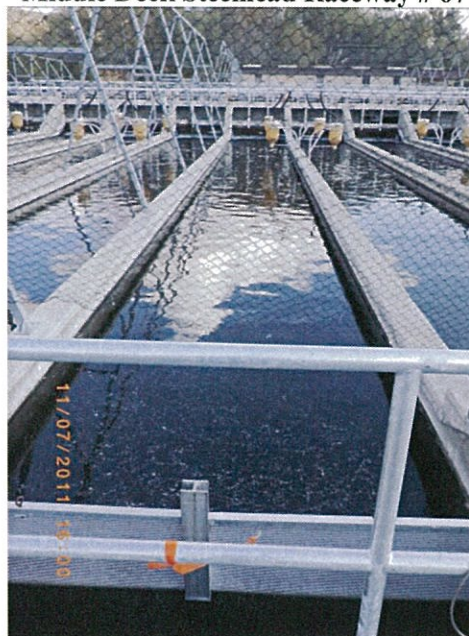
Middle Deck Steelhead Raceway # 67

Note placement of demand feeders at top of raceway away from quiescent zone.

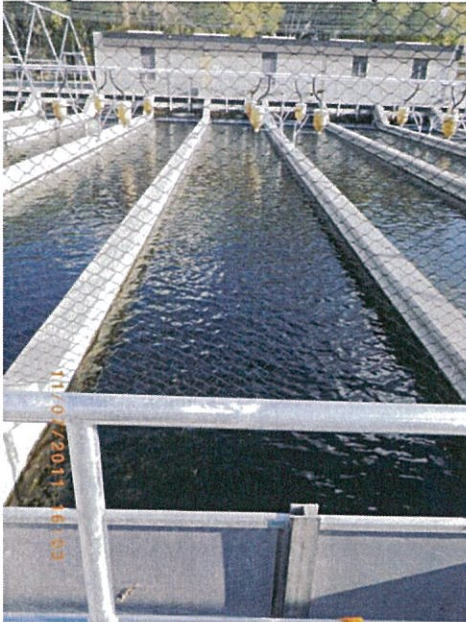
Top Deck Steelhead Raceway # 47

Note placement of demand feeders at top of raceway away from quiescent zone.

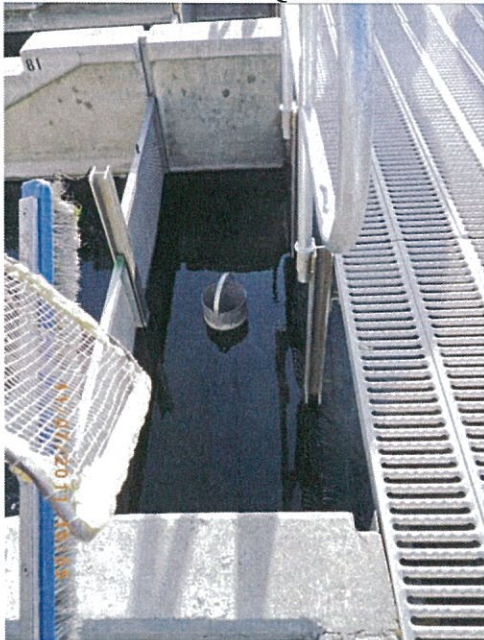
Bottom Deck Steelhead Quiescent Zone # 83

The Quiescent Zone showed no indication or signs of excessive feed at the base. Nor were the barrier board and the dam board showing signs of excessive feeds going over into the tailrace.

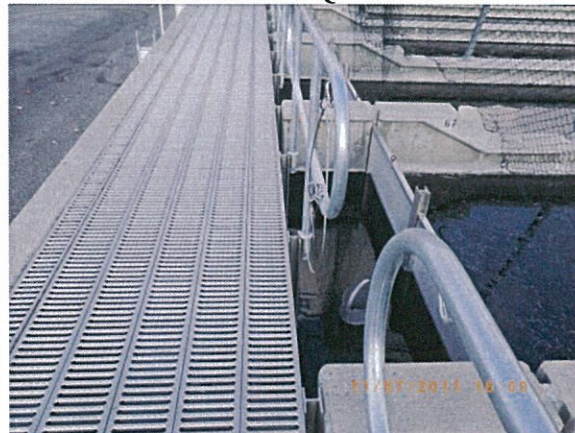
Middle Deck Steelhead Quiescent Zone # 67

The Quiescent Zone showed no indication or signs of excessive feed at the base. Nor were the barrier board and the dam board showing signs of excessive feeds going over into the tailrace.

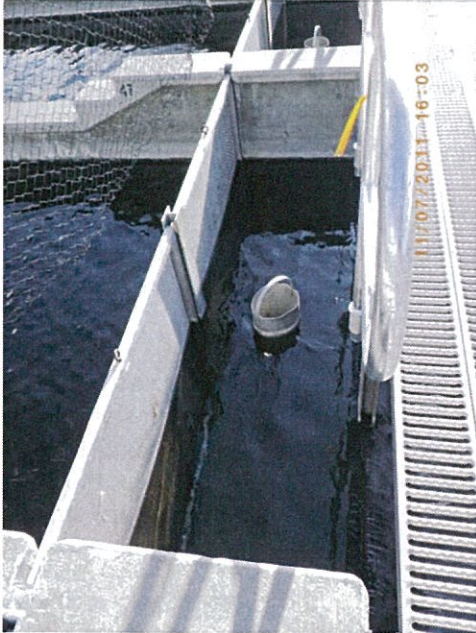
Top Deck Steelhead Quiescent Zone # 47

The Quiescent Zone showed no signs of excessive feed. Signs of excessive feeds going over into the tailrace.

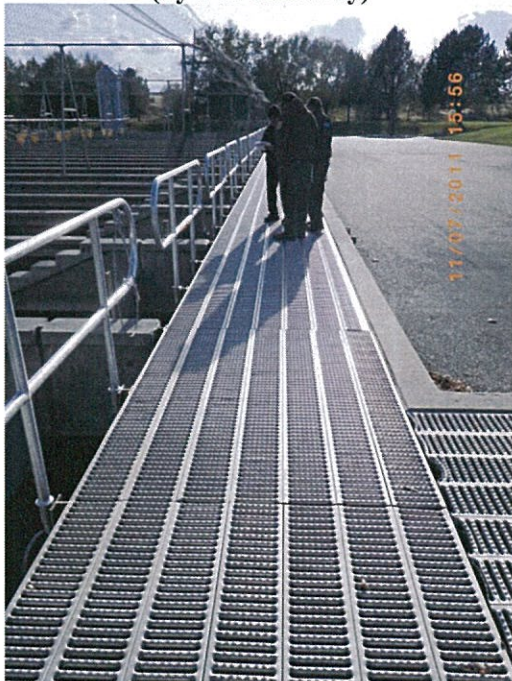
**Bottom Deck Steelhead Tailrace
(by # 83 Raceway)**

Covered stainless steel walkway over the tailrace along the west side of the bottom deck of steelhead raceways.

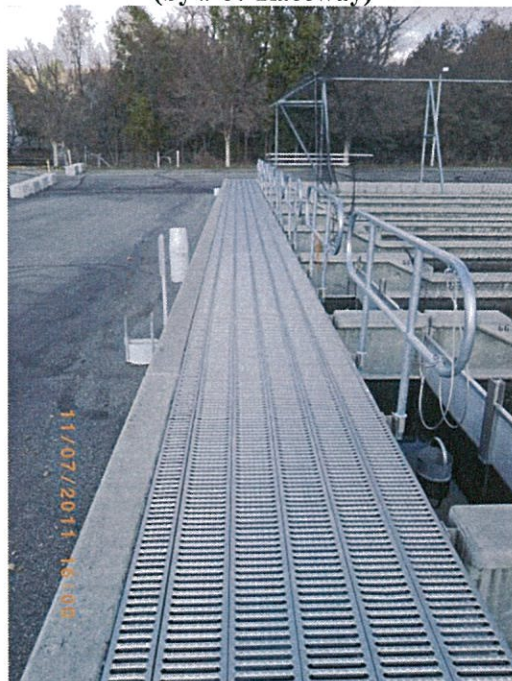
**Middle Deck Steelhead Tailrace
(by # 67 Raceway)**

Covered stainless steel walkway over the tailrace along the west side of the middle deck of steelhead raceways.

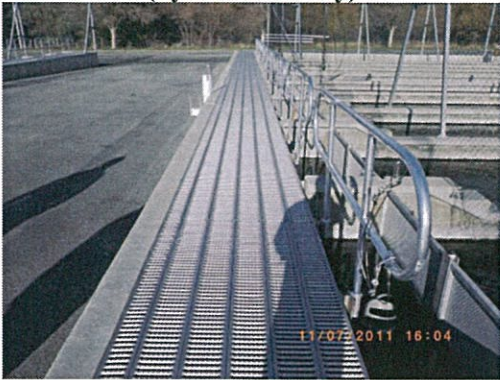
<p align="center">Top Deck Steelhead Tailrace (by #47 Raceway)</p>

<p align="center">Covered stainless steel walkway over the tailrace along the west side of the top deck of steelhead raceways.</p>	<p align="center">General IDEQ Summary of Tailraces:</p> <p>IDEQ looked at the 3 tailraces for the bottom (for 3 raceways), middle (for 3 raceways) and top deck (for 3 raceways) of the steelhead raceways (by peering over the edge of the railings) and noted the following:</p> <ol style="list-style-type: none"> 1. All the dam boards were in secure and in place. The dam boards were recently upgraded to newer boards. 2. No excessive feed was going over the dam boards into any of the tailraces. <p>The tailraces appeared well kept, clean and free of any escapees from the raceways.</p>
<p>Discharges: Mr. Turik and Mr. Trimpey explained that the Steelhead Raceways pass raceway water into the quiescent zones, and then into the tailrace. The tailrace water from the top deck of steelhead raceways discharges into the middle deck of raceways (through their quiescent zones and tailrace) and then to the bottom deck of raceways (through their quiescent zones and tailrace). The tailrace from the bottom deck of raceways is connected to an underground pipe that sends the water to the OLSBs.</p>

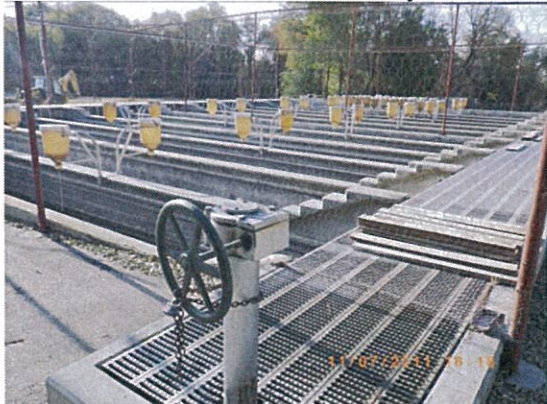
<p align="center">General IDEQ Summary of Trout Raceways:</p> <p>At the time of the inspection the trout raceways were not in production. They were being dried out and prepared for production at a later date. The raceways and quiescent zones appear well kept and clean. Mr. Turik and Mr. Trimpey explained that the dam boards will be replaced with new ones this next coming season.</p>

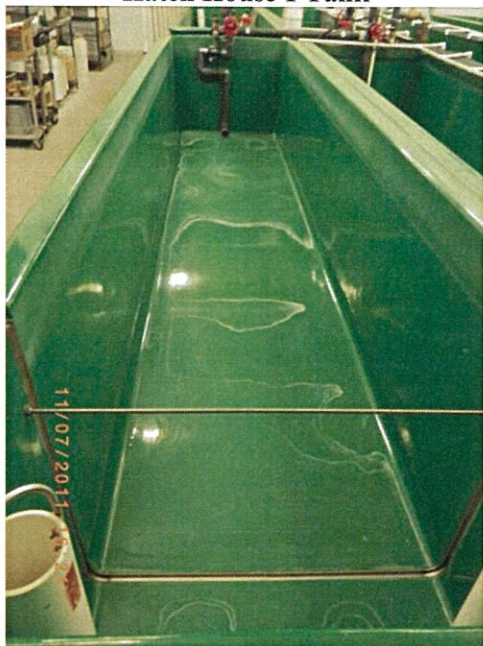
Hatch House 1	
<p>Hatch House 1 Tank</p>

<p>Raceway in one of the tanks. The metal bar separates the location of the raceway and the quiescent zone.</p>	<p>Hatch House 1 Tank</p>

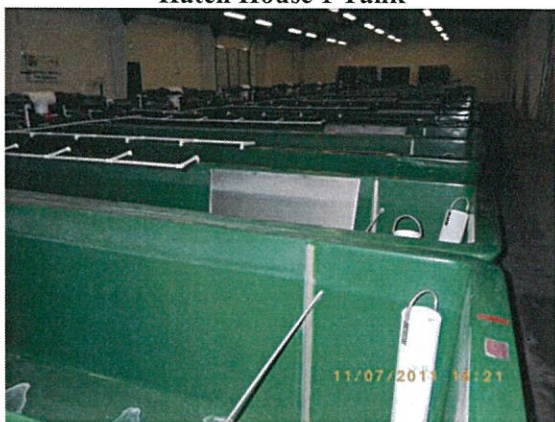
<p>Quiescent Zone in one of the tanks. The metal bar separates the location of the raceway and the quiescent zone.</p>
<p align="center">General IDEQ Summary of Hatch House 1:</p> <p>Production in both Hatch Houses 1 and 2 was down. IDEQ inspection only Hatch House 1. It was clean and well organized. Chemical dip mats for shoes was no present because no fish were present. Mr. Turik and Mr. Trimpey explained that the wastewater is removed from the quiescent zones of the tanks by suction which connects to an underground pipe. This pipe funnels the wastewater to the OLSBs.</p>	
<p align="center">OLSBs AND DISCHARGES TO RECEIVING WATER</p>	
<p>Photo (s) of receiving water(s), particularly documenting any of below:</p>

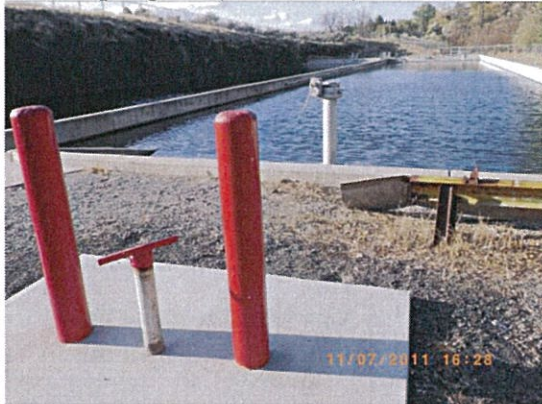
Sampling site (red handle) for OLSBs.

1. OLSBs No. 1 & 2 had no apparent smells or flies. The water clarity was somewhat turbid, with what appeared to be algae, but no macrophytes.
2. Sampling site for influent wastewater to OLSBs is approved site by EPA and IDEQ. No apparent issues from agencies or permittee.
3. Sigma 950 flow meter is functional and records flow as the wastewater leaves the OLSBs.
4. Discharge site from OLSBs into Riley Creek did not appear to have any visible water quality issues. The stream clarity appeared visibly to be similar above and below the discharge site.

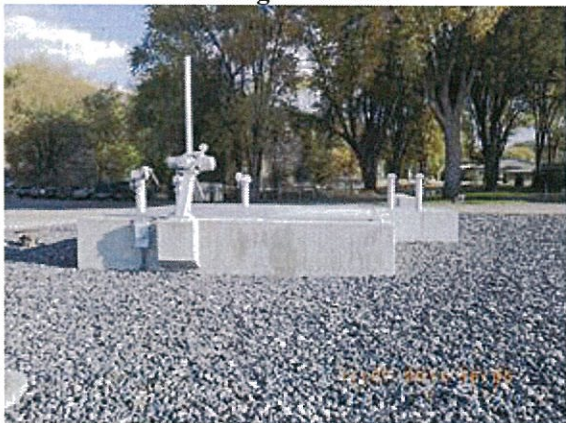
<p>2. Influent Mixing Chamber – This represents three (3) influent sources: (1) Riley Creek, (2) Bickel Springs and (3) Main Spring. Exhibit A, Table 3, provides a description of these influent sources to the facility. This is the primary source of water to the steelhead trout raceways. Flow meters (FM) are located in the three influent sources.</p>	
<p align="center">Mixing Chamber</p>

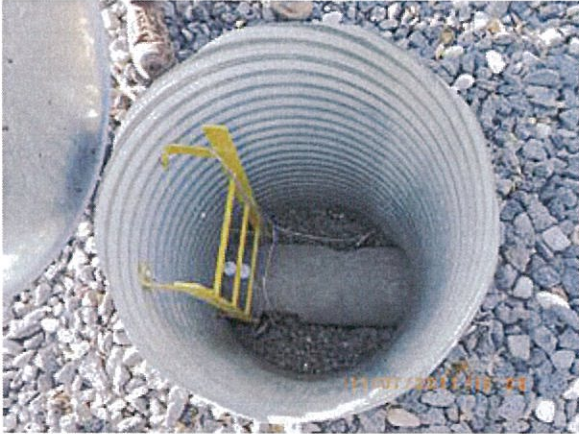
Hatch 2 Ultrasonic Flow Meter

underground in a cylindrical chamber that is attached to the pipe connecting to Hatch 2.

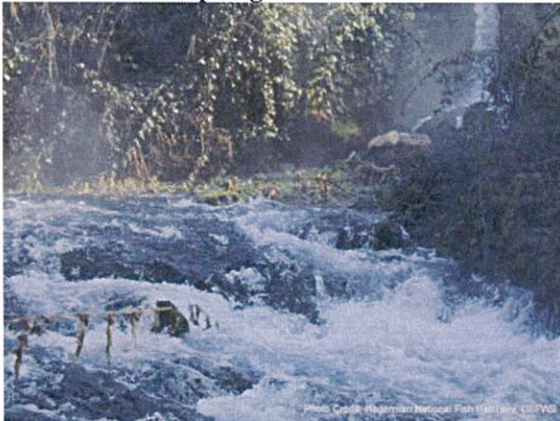
Main Spring Influent Source

4. Main Spring influent source – The Main Spring influent source is combined with Springs No. 12, 13 and 14. See Exhibit A. The influent spring sources are funneled into the 4' Parshall Flume and then into a screen intake.

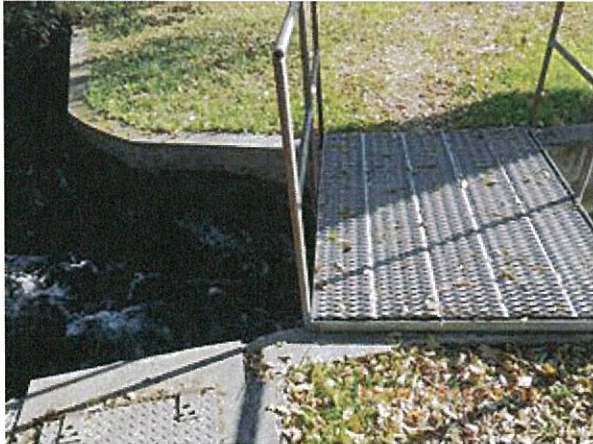
Parshall Flume

This is a 4' Parshall Flume.

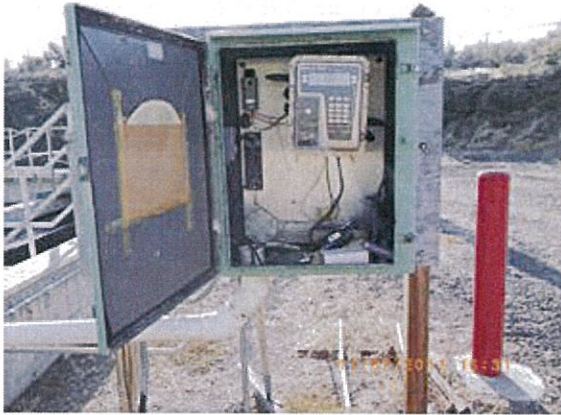
Sigma 950 Flow Meter

5. OLSBs – Sigma 950 flow meter – This is a continuous flow meter that measures the outflow from both the OLSBs into Riley Creek. Both OLSBs are surrounded by a chain link fence to prevent the public from accessing the area. The outflow pipe can be seen discharging into Riley Creek.

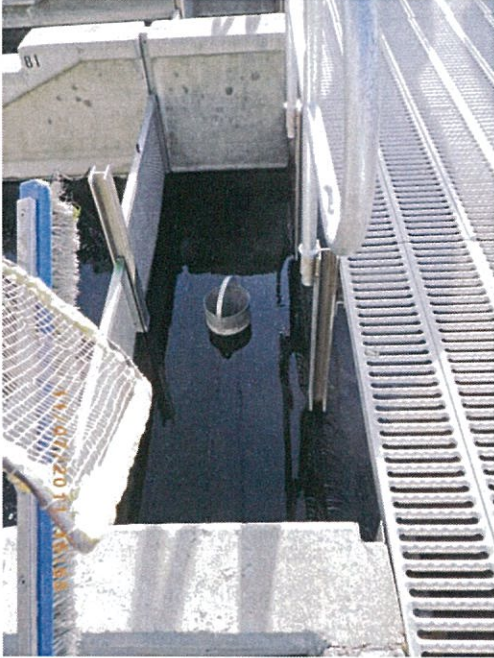
IMG0602.jpg–Bottom Deck Quiescent Zone #83

1. All of the barrier boards were in place and had no excessive feed going over any of them.
2. All of the dam boards were in place and had no excessive feed going over them into the tailrace.
3. There were no fish observed in any of the quiescent zones.

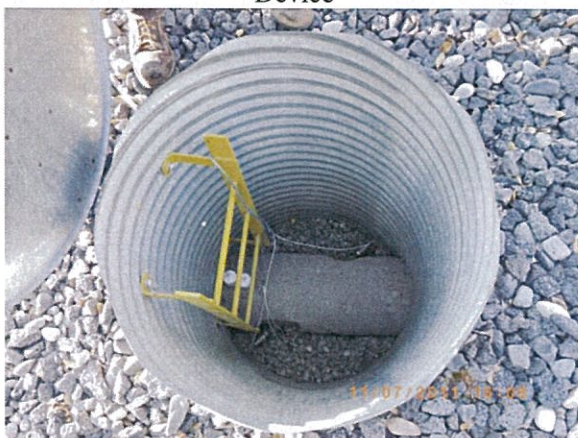
IMG0612.jpg-Hatch 2 Ultrasonic Flow Measuring Device

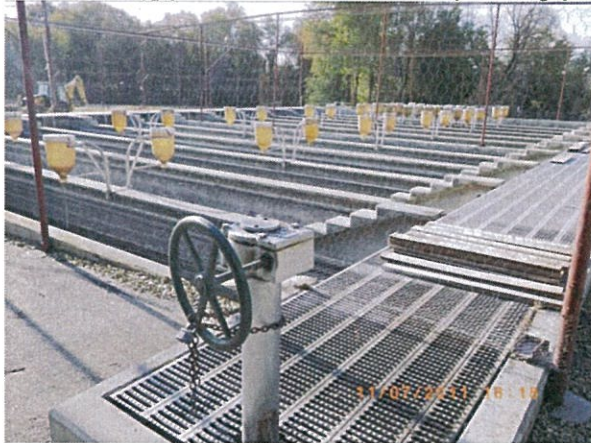
IMG0616.jpg-Rainbow Trout Raceways - Empty

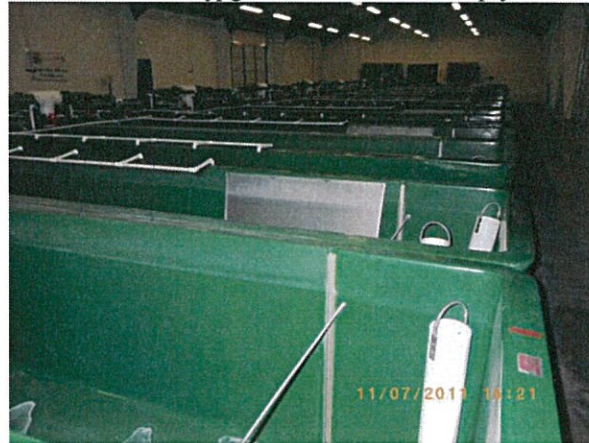
IMG0617.jpg-Hatch 1 Tanks - Empty

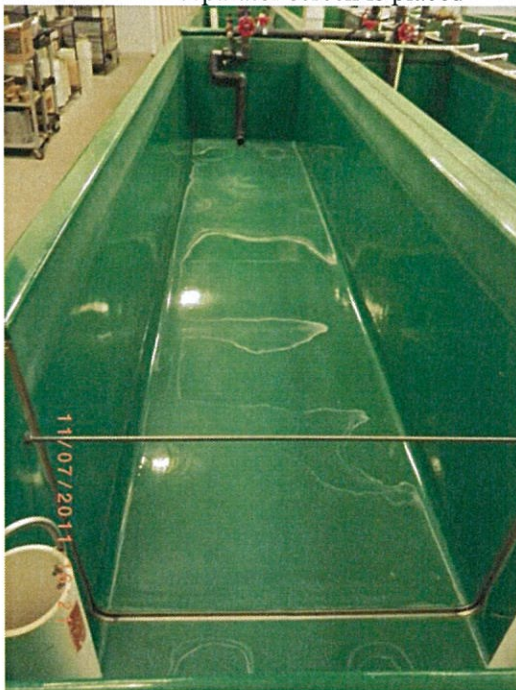
IMG0618.jpg-Hatch 1 Tank showing Quiescent Zone below and Raceway above separated by metal bar where separator screen is placed

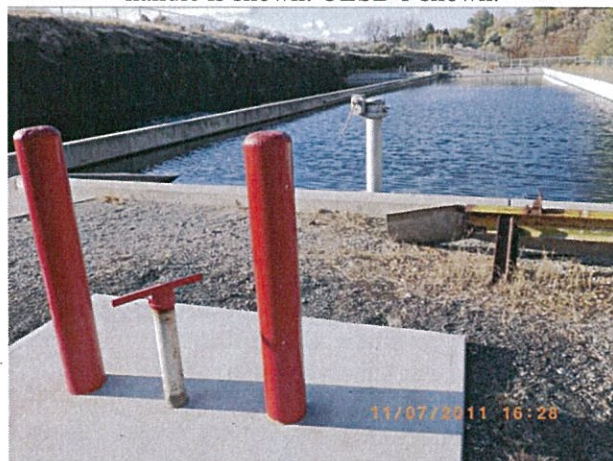
IMG0619.jpg-Sampling site (red handle) for OLSBs. Site is between the two metal iron red posts where red handle is shown. OLSB 1 shown.

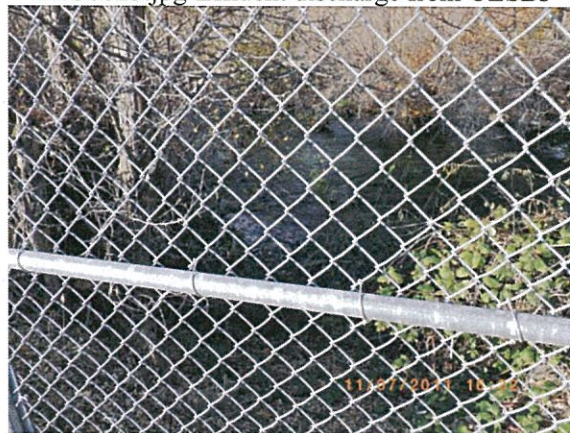
IMG0623.jpg-Effluent discharge from OLSBs

<p>3. Any floating or suspended or submerged matter, including dead fish, in amounts causing nuisance or objectionable condition? – IDEQ did not see any of these in the downstream sites below the discharge of the OLSBs into Riley Creek. Containment of these contaminants appears to be effective in the OLSBs.</p>	<p>Yes No – Mr. Turik and Mr. Trimpey confirmed this.</p>
<p align="center">FLOW MEASUREMENT DEVICE(S)</p>	
<p>1. Were flow measurements taken during inspection? – In previous compliance inspections the facility has shown IDEQ how flow measurements are taken. In this CEI IDEQ did not request a demonstration of this procedure.</p>	<p>Yes No – IDEQ did not request to see how flow measurements were taken.</p>
<p>Photo (s) of taking flow measurement: No flow measurements were taken during the CEI site tour of the facility. IDEQ did not do a site inspection of all the influent sources for the facility because in previous inspections some of these sites were visited. Only the following sites were inspected where flow is either taken on-site or taken at a location where various influents are collected together.</p>
